Water supply to the Syrian bombed site: what it is telling us

Robert Kelley

Associate Senior Research Fellow, SIPRI

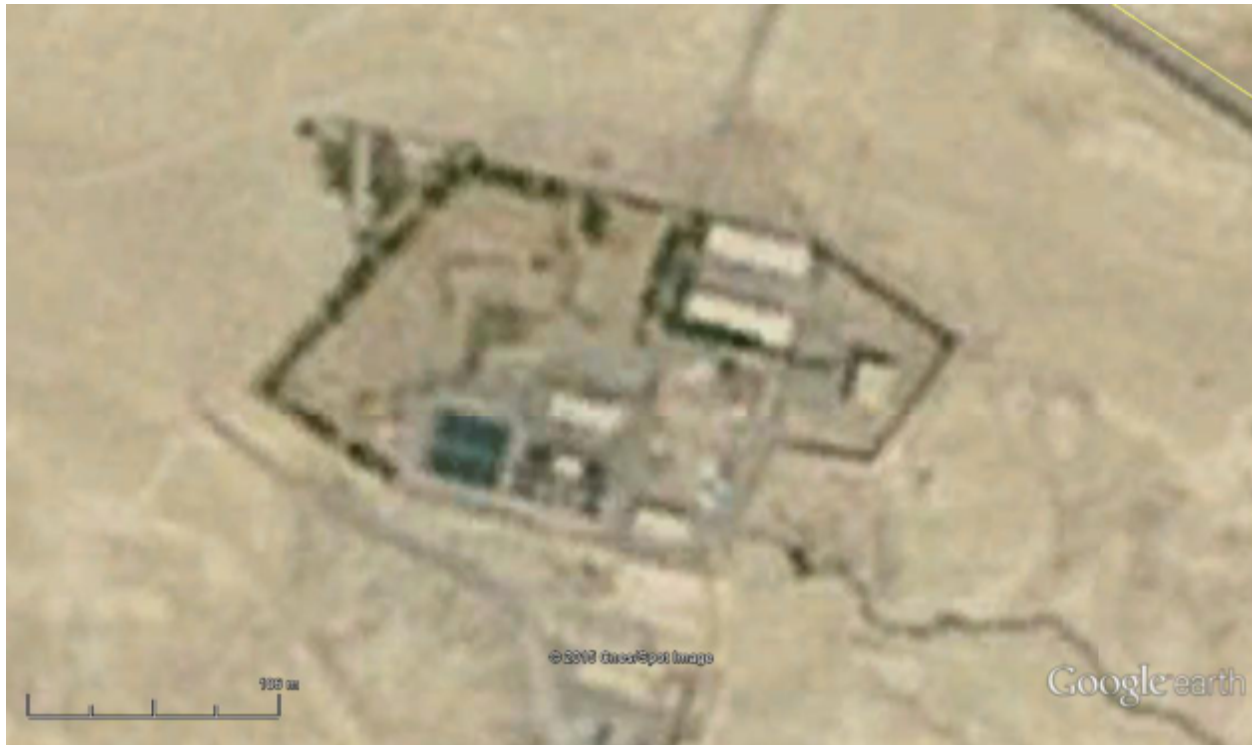
Figure 1. The Desert Water Treatment Plant is well established even in 2004.

The first thing that is clear is that a large, modern water treatment plant was built in the desert long before the AK bombed building was completed. This Desert Water Treatment Plant (DWTP) is clearly visible in 2004 Google Earth imagery when the bombed building was still under construction. In 2004, mature trees around the perimeter of the DWTP are already clearly visible. There are no other customers for this water treatment plant so its connection to Al Kibar is perfectly clear.

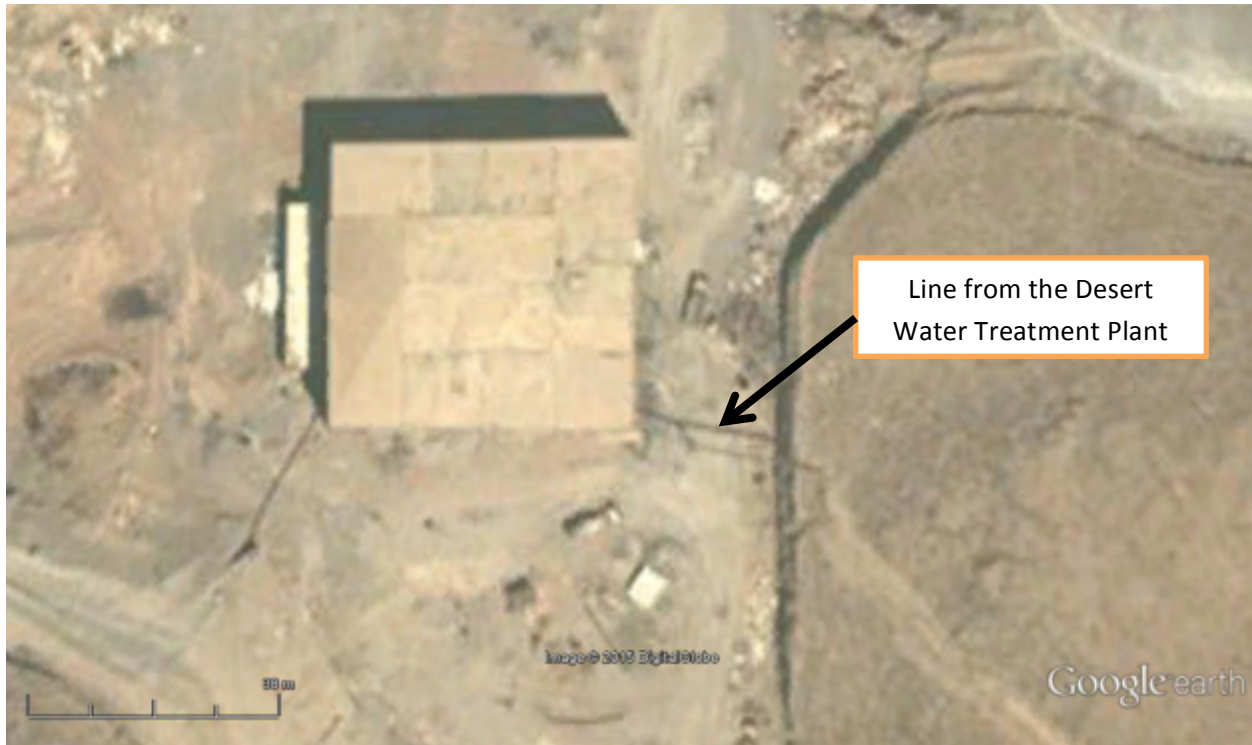
The trace of a pipeline from the DWTP to the AK under construction is clearly visible in 2004. The most obvious good road to the AK is from the DWTP and not from the shortest route to the Euphrates. There is no security fence or perimeter protection at AK. By 2007 the pipeline connecting the DWTP to the Al Kibar bombed building is clearly visible.

Figure 2. A water supply to the building comes from the DWTP in 2007.

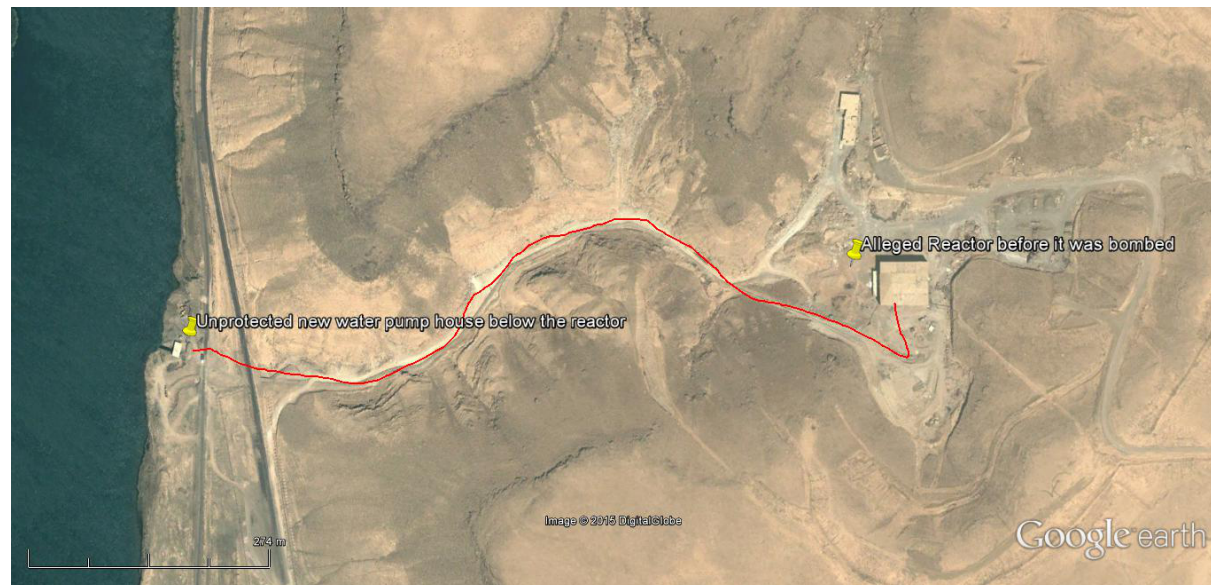
The new pump house is similar in size to the DWTP pump house. It is located just 25 metres from a north-south public highway and has no security fences, guard house or any other visible protection. The water line from the pump house must pass under the public highway and a nearby railroad track and there is no protection of the corridor for the pipe. A small lagoon connects the pump house to the Euphrates River. It is a completely unprotected facility that would be critical to the operation of an allegedly strategic site.

Figure 4. The new unprotected pump house would pump water up hill to the building according to IAEA. The pipeline passes under two right-of-ways without fencing or protection. The better road to the site leads from the DWTP and not up the canyon from the river. There is no major security checkpoint on either road leading to the building, a building which supposedly housed a reactor core load of uranium fuel.

Significantly, the pump house is about 60 metres below the AK building and there are no storage ponds or reservoirs in the route. If there is any interruption in pumping capacity from the river pump house to the presumed reactor, such as electric power failure or sabotage, cooling will stop immediately and the reactor might melt down. There is also no water treatment facility in this route so the river pump house will be sending raw river water with debris and silt into the reactor heat exchangers. This is not common practice. It is clear that this pump house is not the primary source of cooling for the AK and at best is a secondary supply.

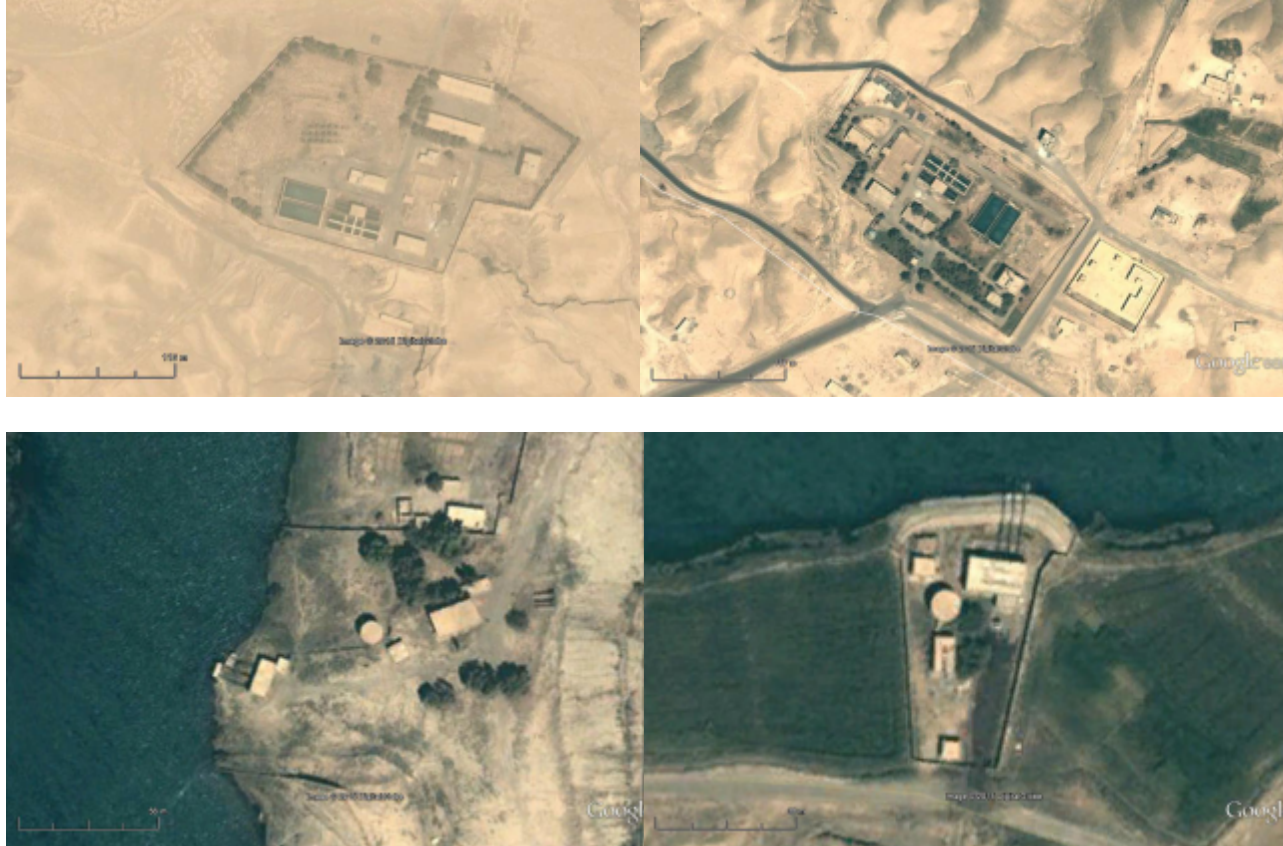
Figure 5 The DWTP and its riverside pumping station are visible on the left and the nearly identical Tibni water treatment plant is on the right. Clearly they were built from the same engineering drawings

The second plant is the Tibni water treatment plant. It is secured by a wall all around and a secure entry point, as is its pumping station. It is located a mere 10 kilometres from the Euphrates pumping house for the DWTP. It is connected to the Tibni Salt Mine operated by the GECOPHAM (General Company for Phosphates and mines). GECOPHAM has been doing pilot extraction of uranium with IAEA/UN assistance from phosphate fertilizers at Homs, Syria.⁹ Tibni has been studied as storage site for the permanent disposal of Normally Occurring Radioactive Material (NORM) with IAEA review.¹⁰ Tibni has seen both physical modifications and a large drop in salt output since the Al Kibar bombing. At the very minimum Tibni is the most likely site for disposal of the debris from the Israeli bombing. In the worst case, there is another concealed industrial facility there, with process water from a strategic water treatment plant identical to the one supporting Al Kibar. These features and other aspects of the Al Kibar analysis were communicated to the IAEA in 2010 prior to publication in Jane's, as a courtesy.¹¹ The IAEA replied that it was not convinced.¹² The nonproliferation community should be interested in these facts even if the IAEA is not.
