## Cutting Through the Fog on 'Possible Military Dimensions' to Iran's Nuclear Programme: Large berm at the end of the building at Parchin

by Robert Kelley

### Large berm at the end of the building

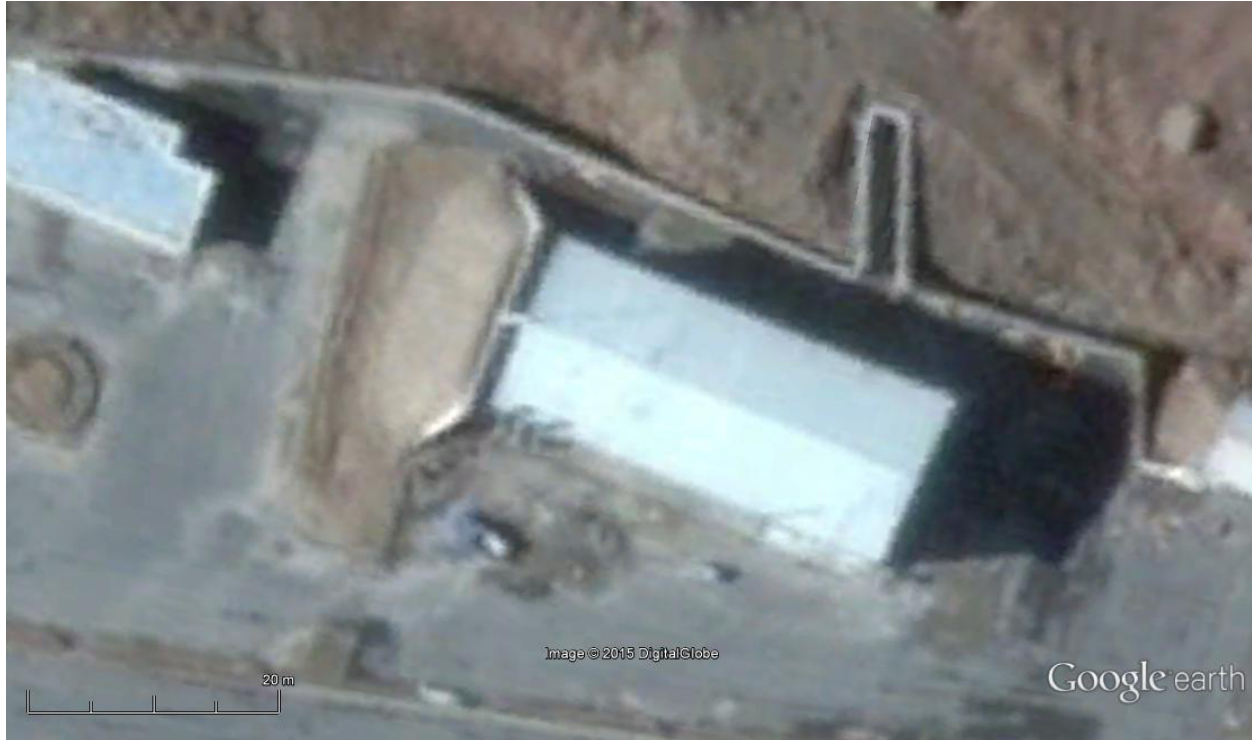
29 November 2014

Is the berm at the end of the building consistent with high explosives protection? For starters, the berm is very small compared to other berms at Parchin. And we only have to study the dozens of explosives handling buildings within a few kilometres to see that this one is different.

The Parchin “berm” fails all these tests. It is a big flat concrete shielding wall that forms a driveway at the south end of the building. It only protects one small nearby building but not people on the road running through the site to the north end, and neither its parking lot nor the other end of the building of interest. (The rocky bluff protects the fourth side.) The wall extends out only a few metres from the angle of hazard of postulated explosives.

There is a much simpler explanation. The concrete wall is clearly for protection against a hazard. It has earth piled behind it. It is on one end of the building because the hazard it is protecting against is only directed to this end. The most logical reason to have a wall with earth behind it in this industrial situation is called a “beam stop” for a powerful industrial x-ray machine or accelerator commonly used for non-destructive testing of welds and internal structure of items being manufactured. It is shielding for x-rays, not explosives. It is located close to the building to stop x-rays that are being scattered by objects and walls.
